**STUDY & RECOMMENDATIONS  
OF DRAINAGE IMPROVEMENTS TO  
THE GLENVIEW ROAD  
DRAINAGE DITCH & CULVERT**

**THE BOROUGH OF NORTH CALDWELL**

**PETRY ENGINEERING, LLC**

**JANUARY 10, 2019**

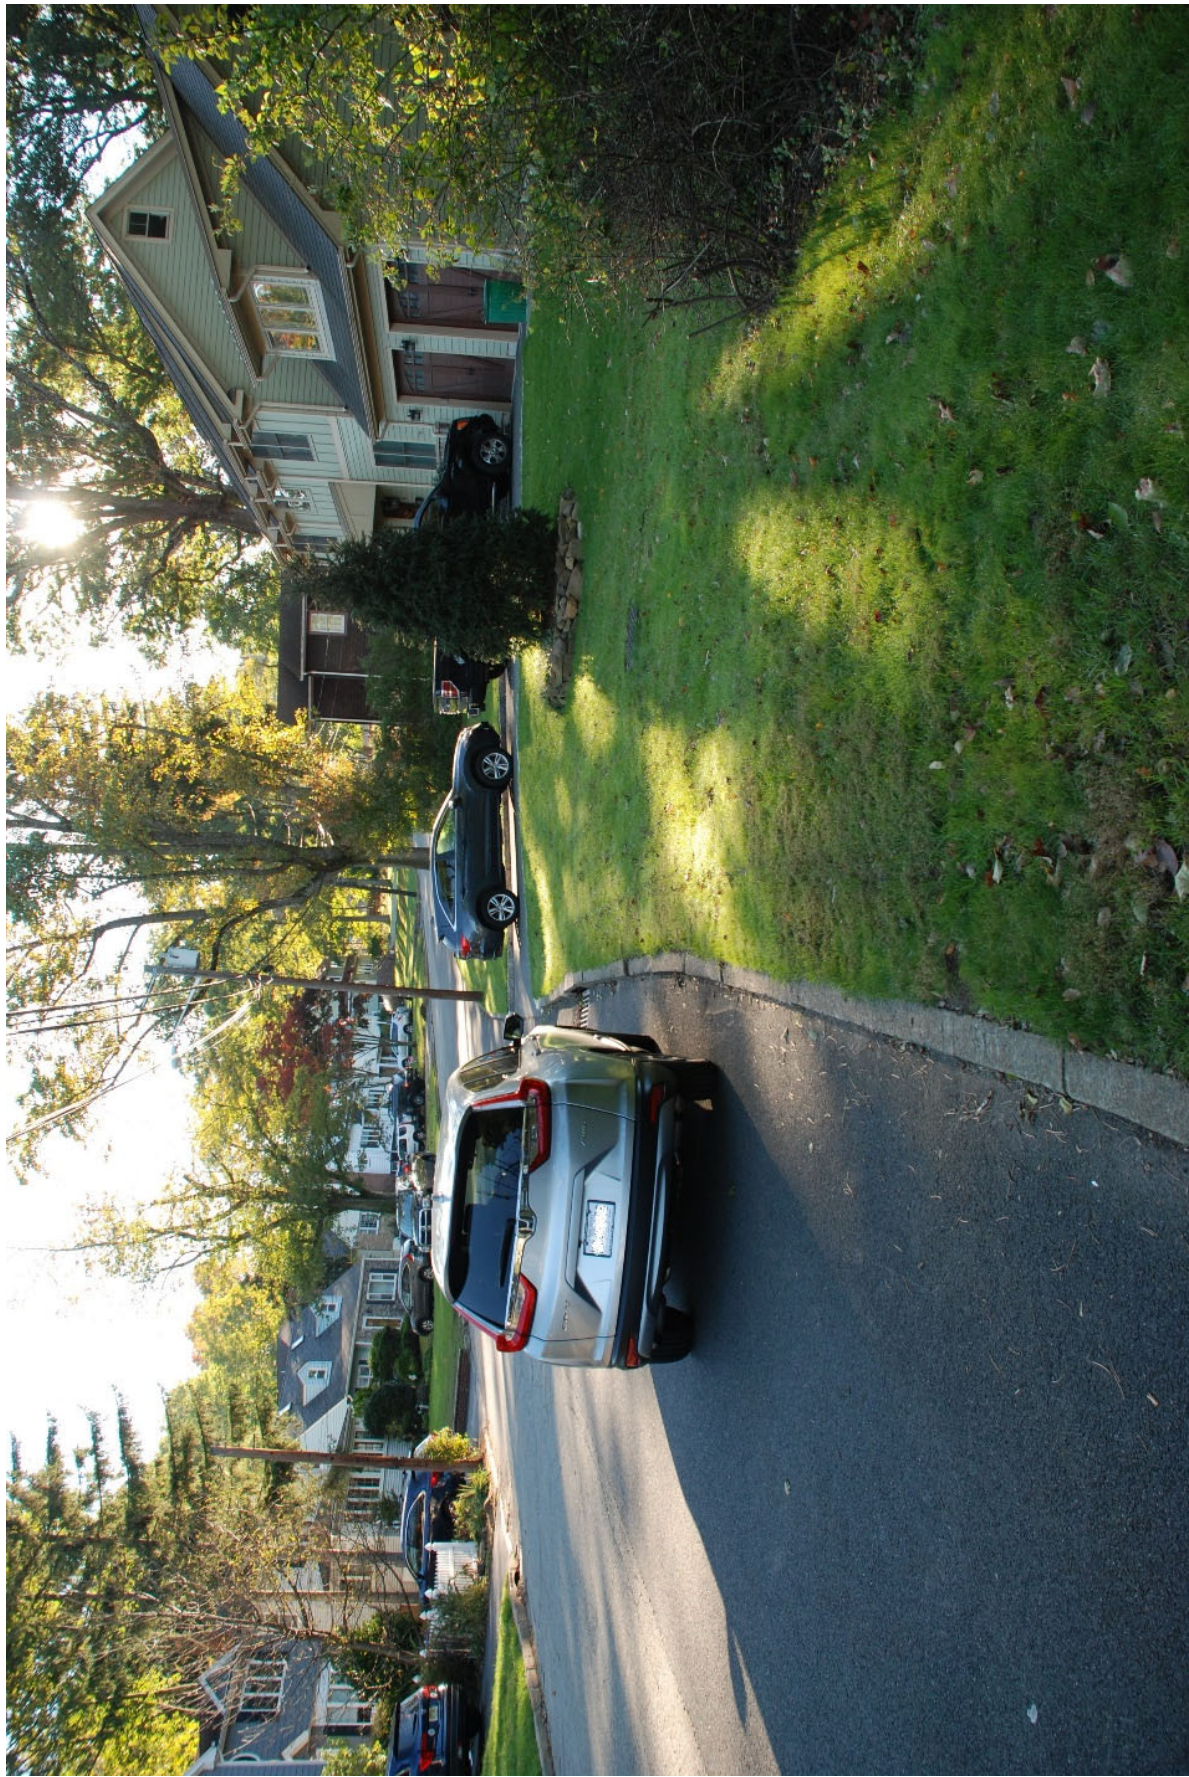
Photo 1 – View looking East at an overview of Glenview Road and location where the culvert (described below) passes beneath Glenview Road.

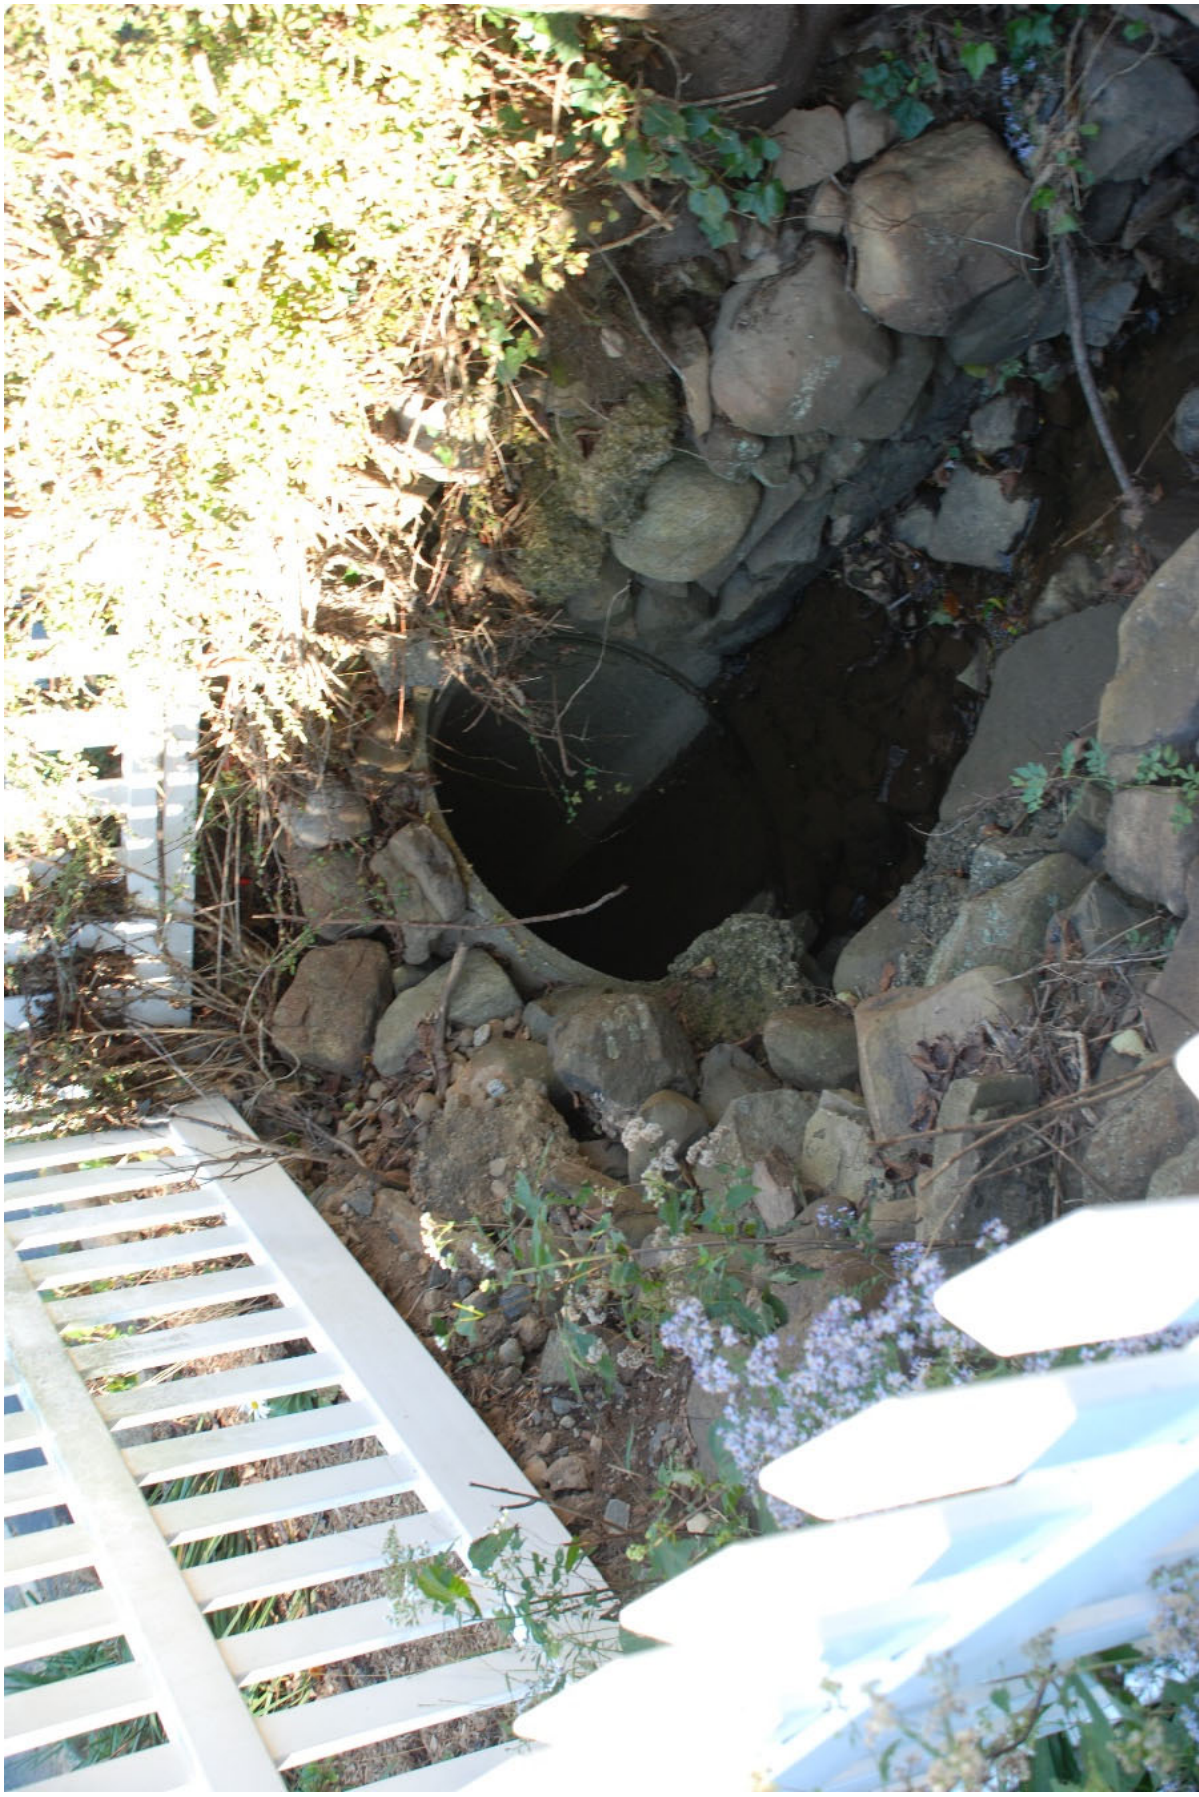
The culvert itself consists of two pipes in series, a 36-inch reinforced concrete pipe (RCP) followed by a 60-inch by 41-inch corrugated metal elliptical pipe (CMEP). The 36-inch pipe is the more restrictive of the two and, therefore, it was utilized in the modeling of the conditions. The existing 36-inch RCP does not have a headwall, which impacts the modeling of the culvert conditions.

Photo 2 – View Looking West at the upstream portion of the culvert and northeast of Glenview Road. The Un-Coded Tributary enters here before passing through a 36" RCP pipe which passes beneath Glenview Road. Note the historic channelization of the stream through the placement of rocks along the banks.

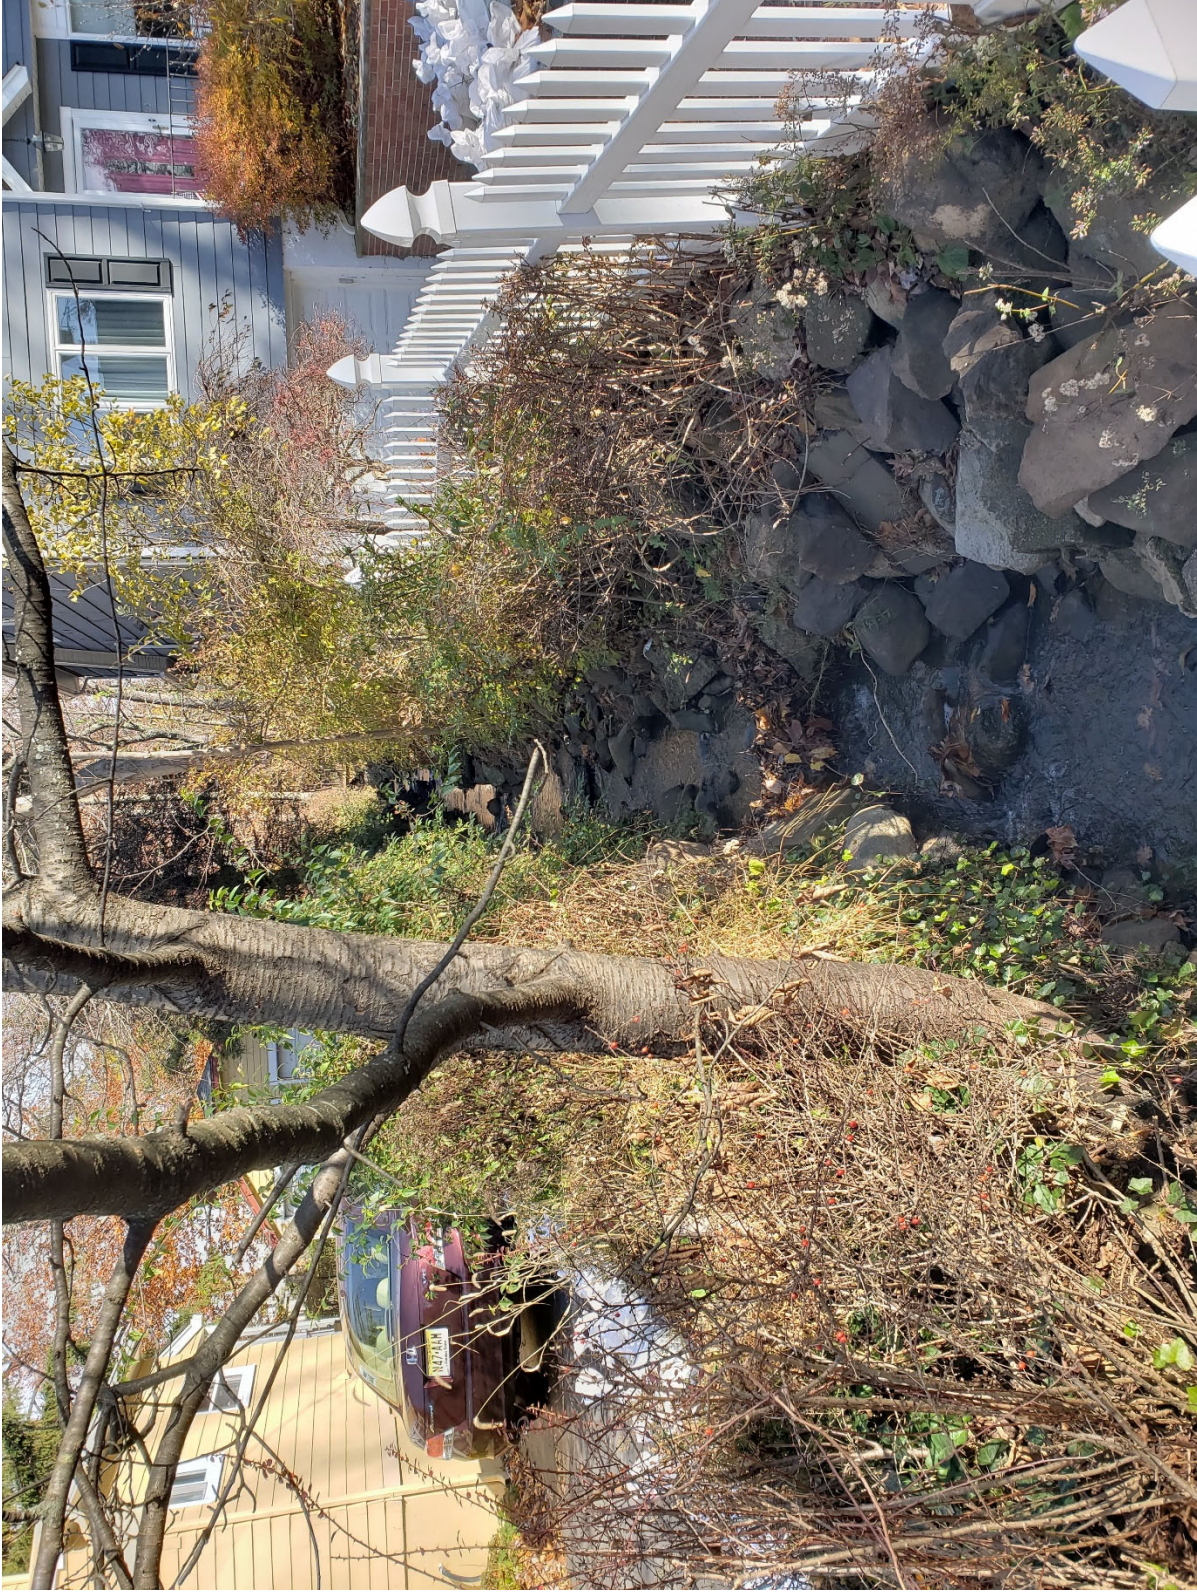
Photo 3 – View looking North at the portion of the channel that feeds into the upstream most portion of the culvert, shown in Photo #2. This picture is taken looking upstream and shows the proximity of the stream to the driveway location on 17 Glenview Road and the home of 19 Glenview Road.

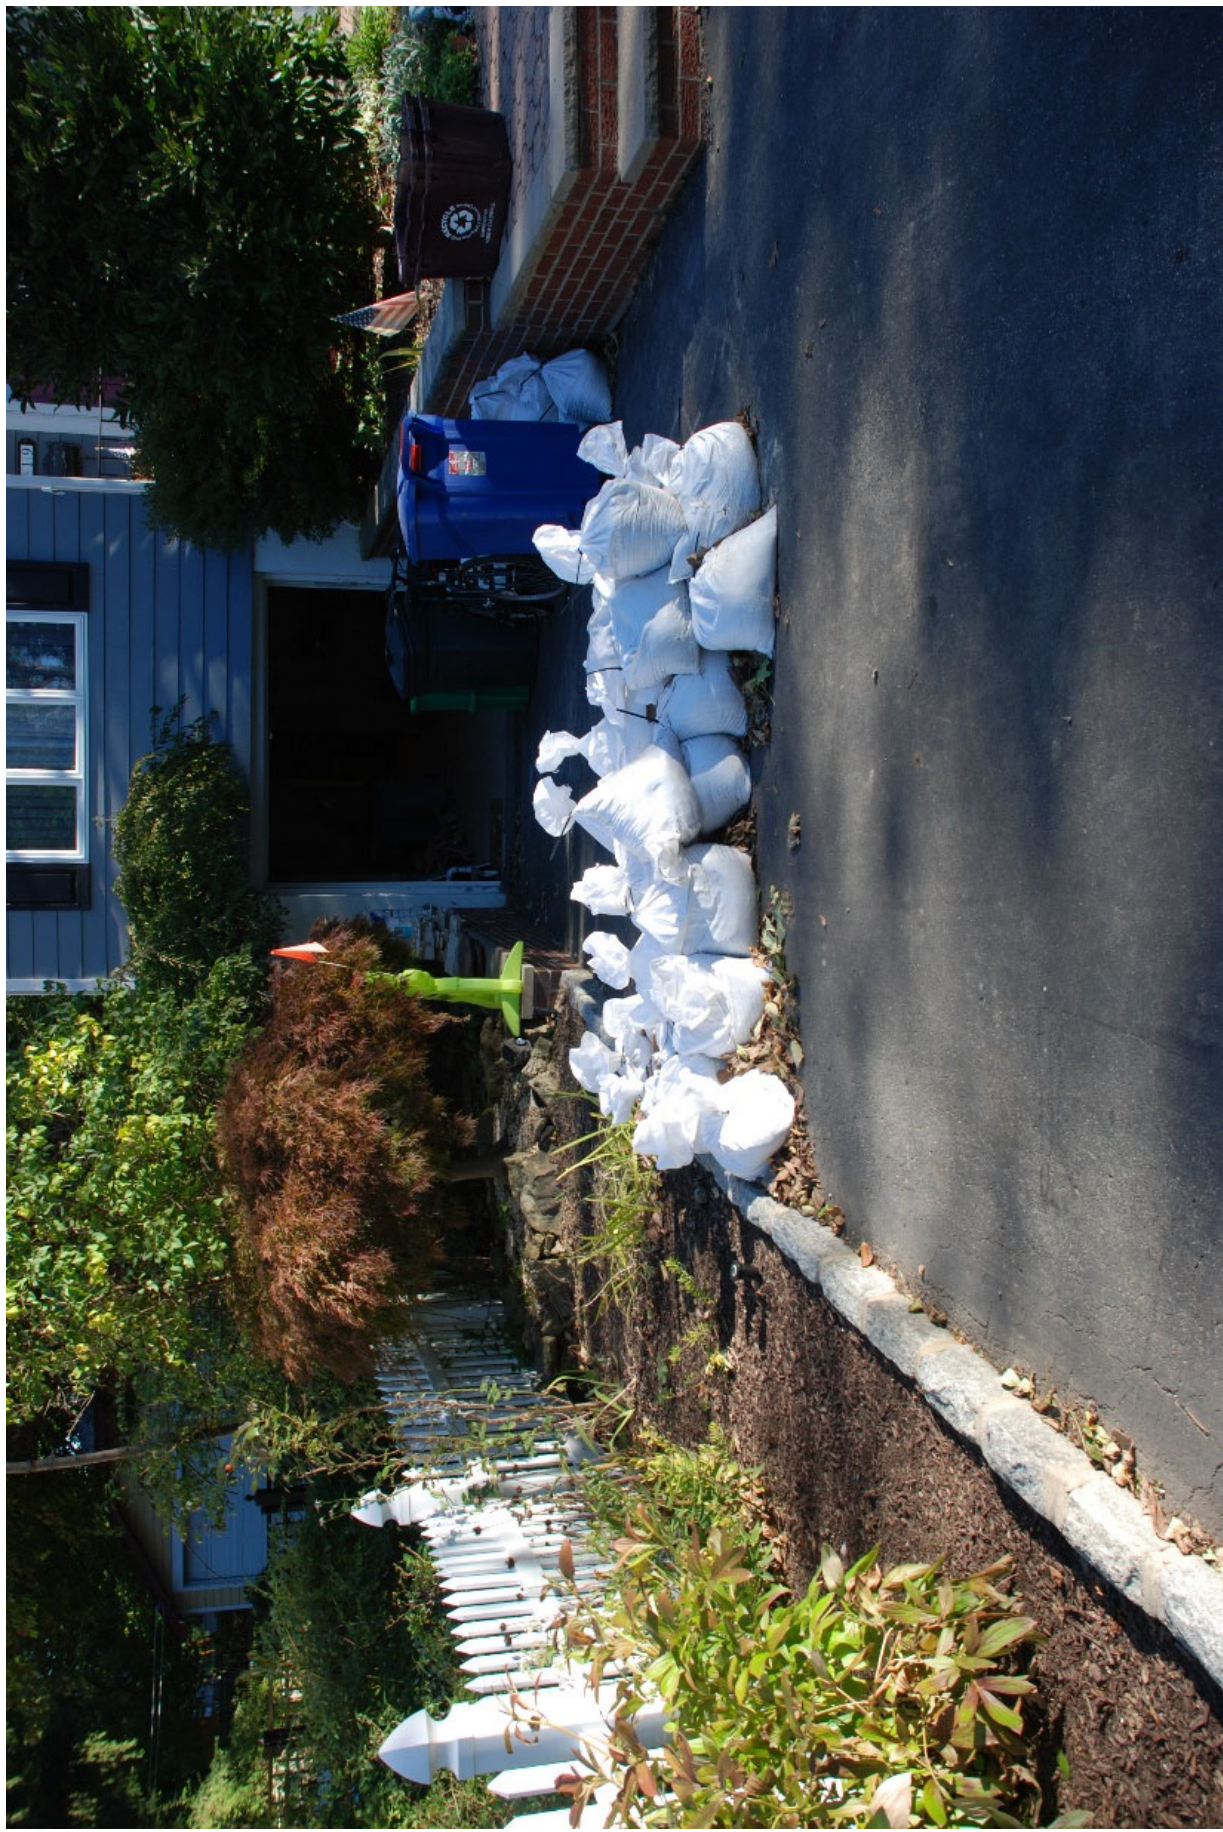
Photo 4 – View Looking North. The picture shows the proximity of the stream to the home at 19 Glenview Road. Sandbags were placed at 17 and 19 Glenview Road as a temporary precaution to prevent any future flooding in the respective homes.

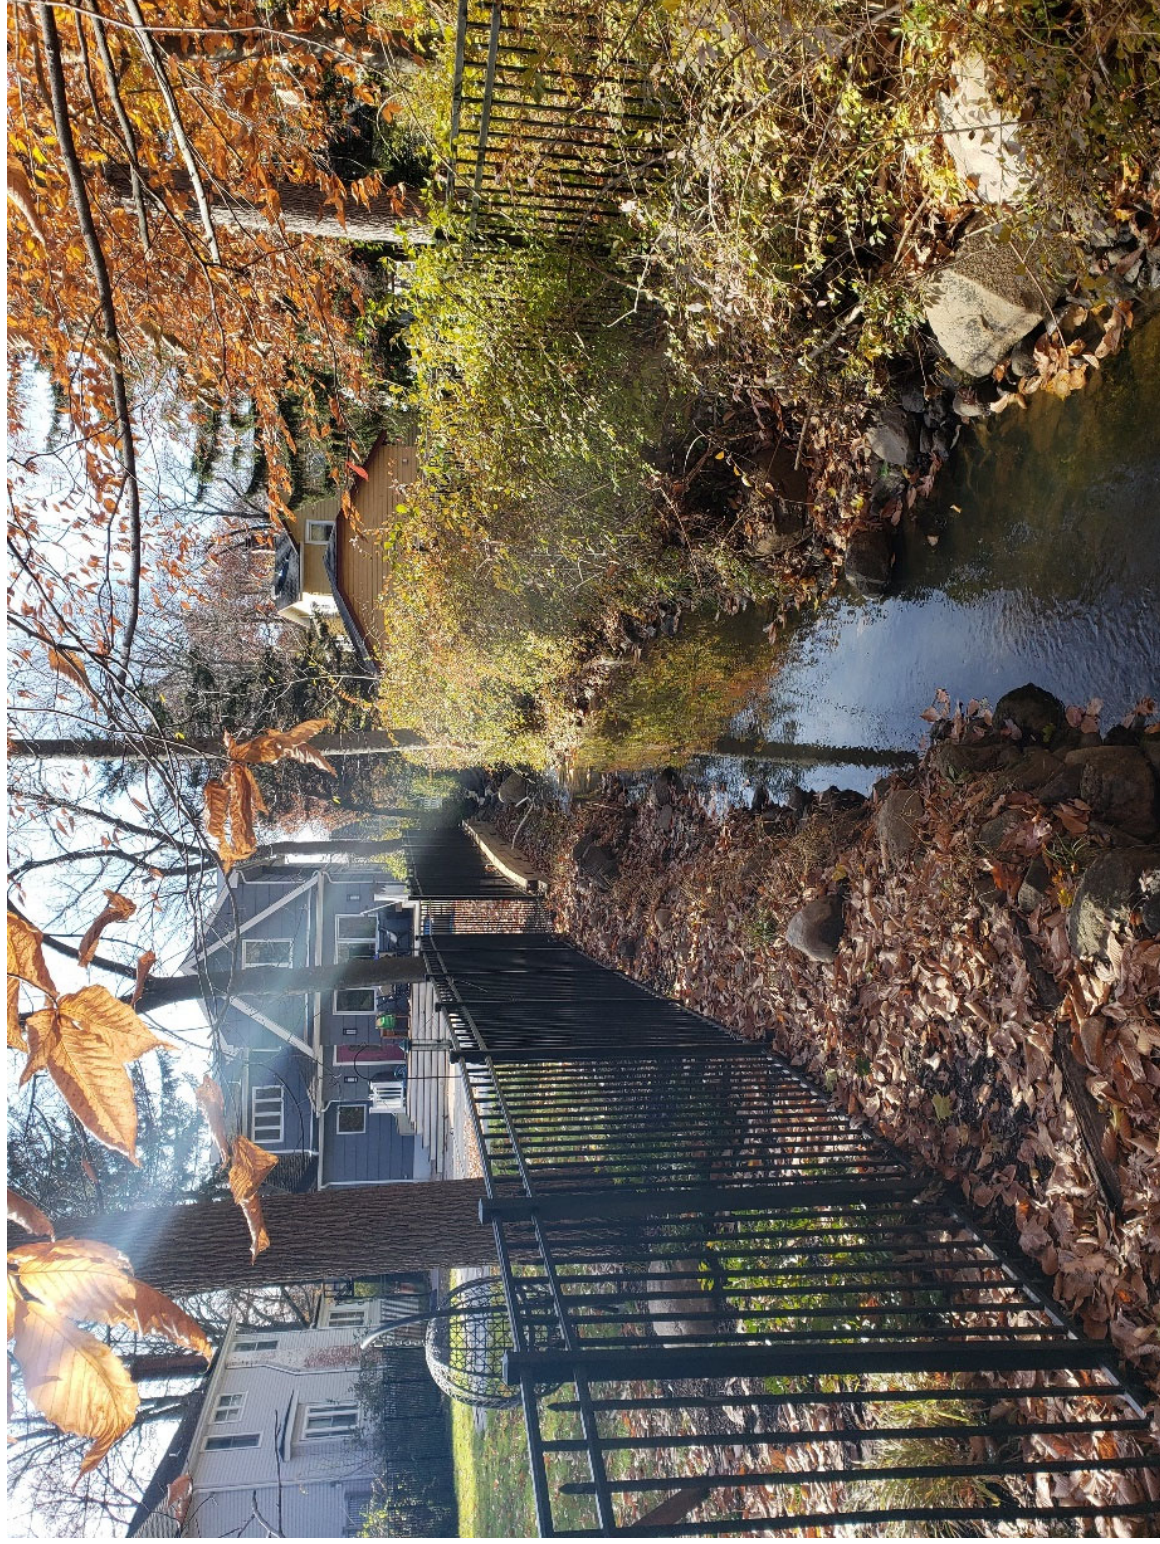
The majority of the channel within the study area, both upstream and downstream of the culvert, is in its natural state. However, the area between 17 and 19 Glenview shows signs of man-made changes, likely due to the tight proximity of the improvements within those two properties. Within this reach, the channel is primarily stone-lined and shows a reduced cross-section. The stone lining within the channel reduces its capacity.

Photo 5 – View looking South. This picture was taken looking downstream at the Un-Coded Tributary as it passes between 17 and 19 Glenview Road. The photos location is upstream of Photo #3. There are signs of historic channelization and disturbances along the banks of the stream.

Our analysis shows that, while the culvert is undersized and causes back-up to occur, the modified channel between #17 & #19 does not have adequate capacity to convey the higher storms to the culvert. As such, just replacing the culvert will not solve the problem. The channel between these two homes needs to be modified in order to alleviate the flooding conditions.

The evaluation of the channel as it approaches the culvert requires a modification that includes widening the bottom of the channel and changing the side slopes. Because the slopes will need to be steeper, the entire channel will need to be constructed of rip-rap at a minimum from the rear of the 17/19 properties and up to the culvert. In order to convey the NJFHADF, the channel located between the two houses will need to have vertical walls

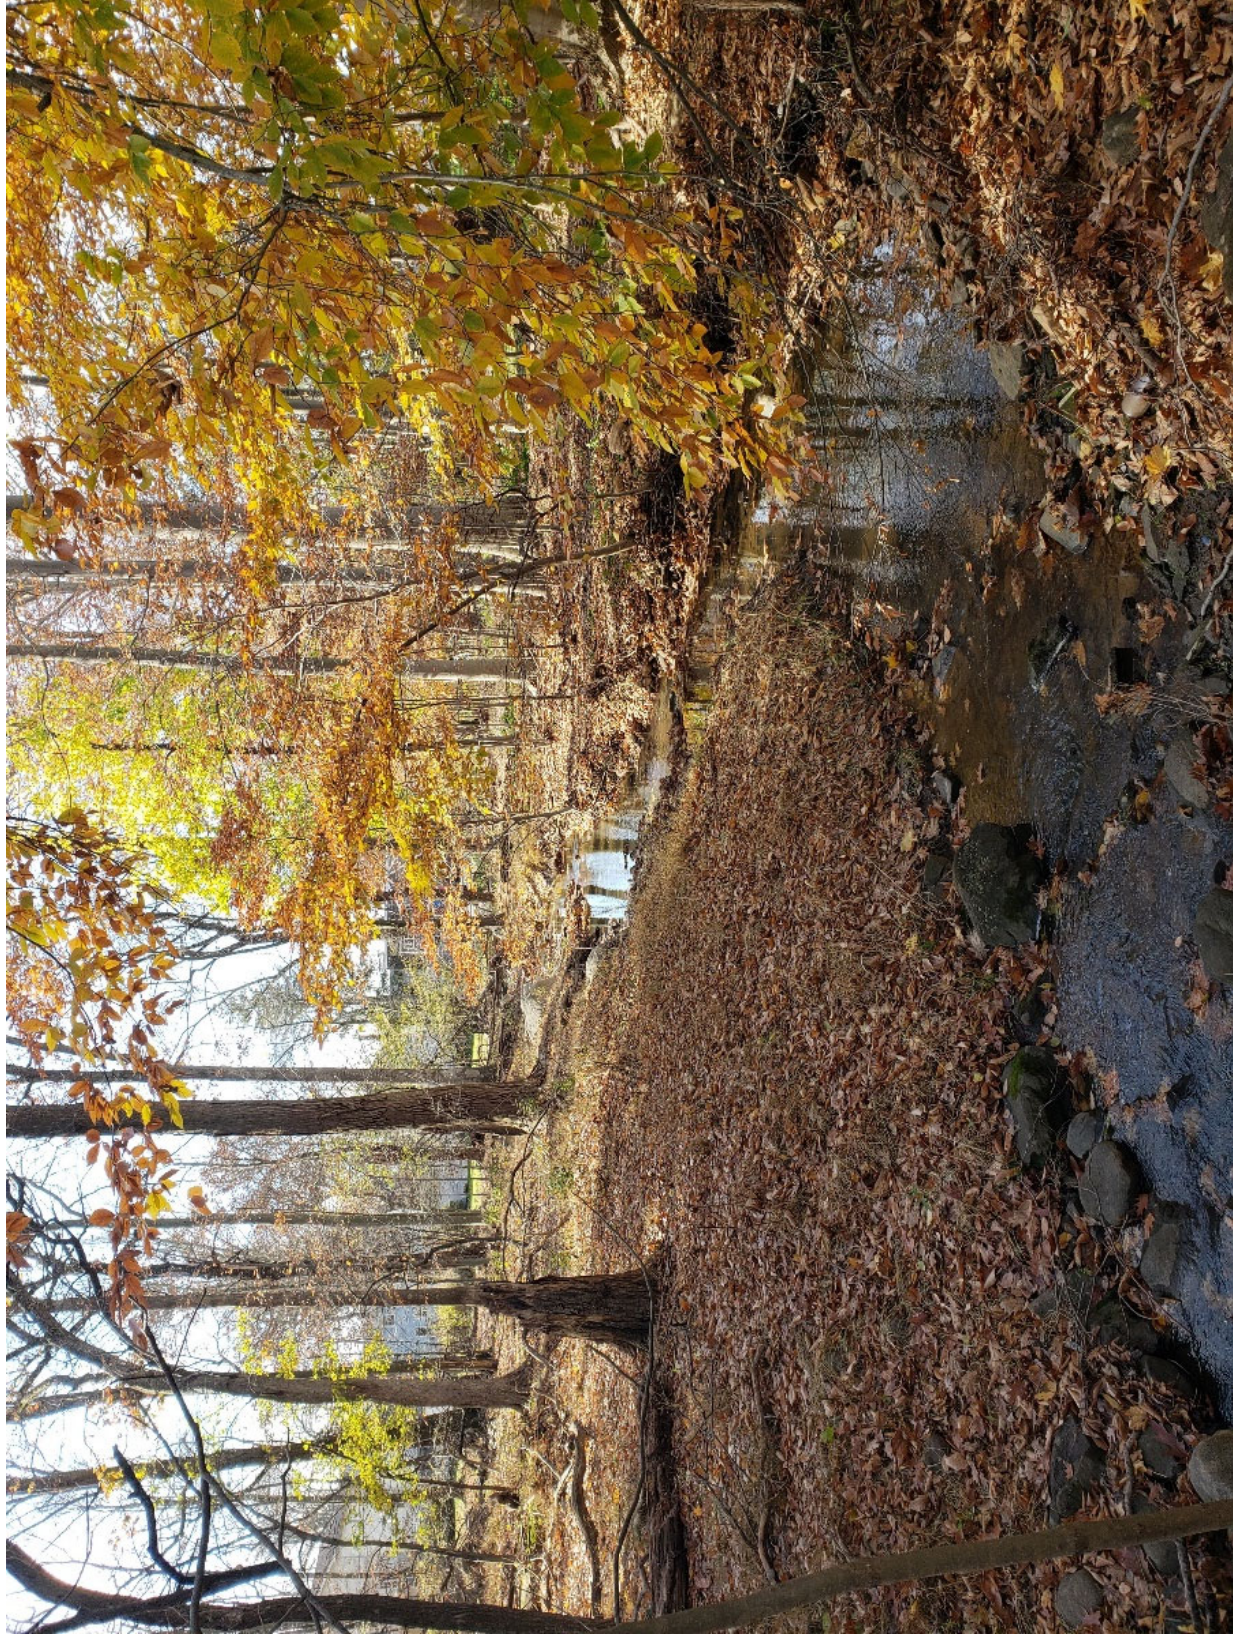
Photo 6 – View looking South. This photo is taken looking downstream, but upstream of Photo #5. This is within the undisturbed wooded portion of the stream. You can see the home located at 19 Glenview Road through the trees in the center of the photo.

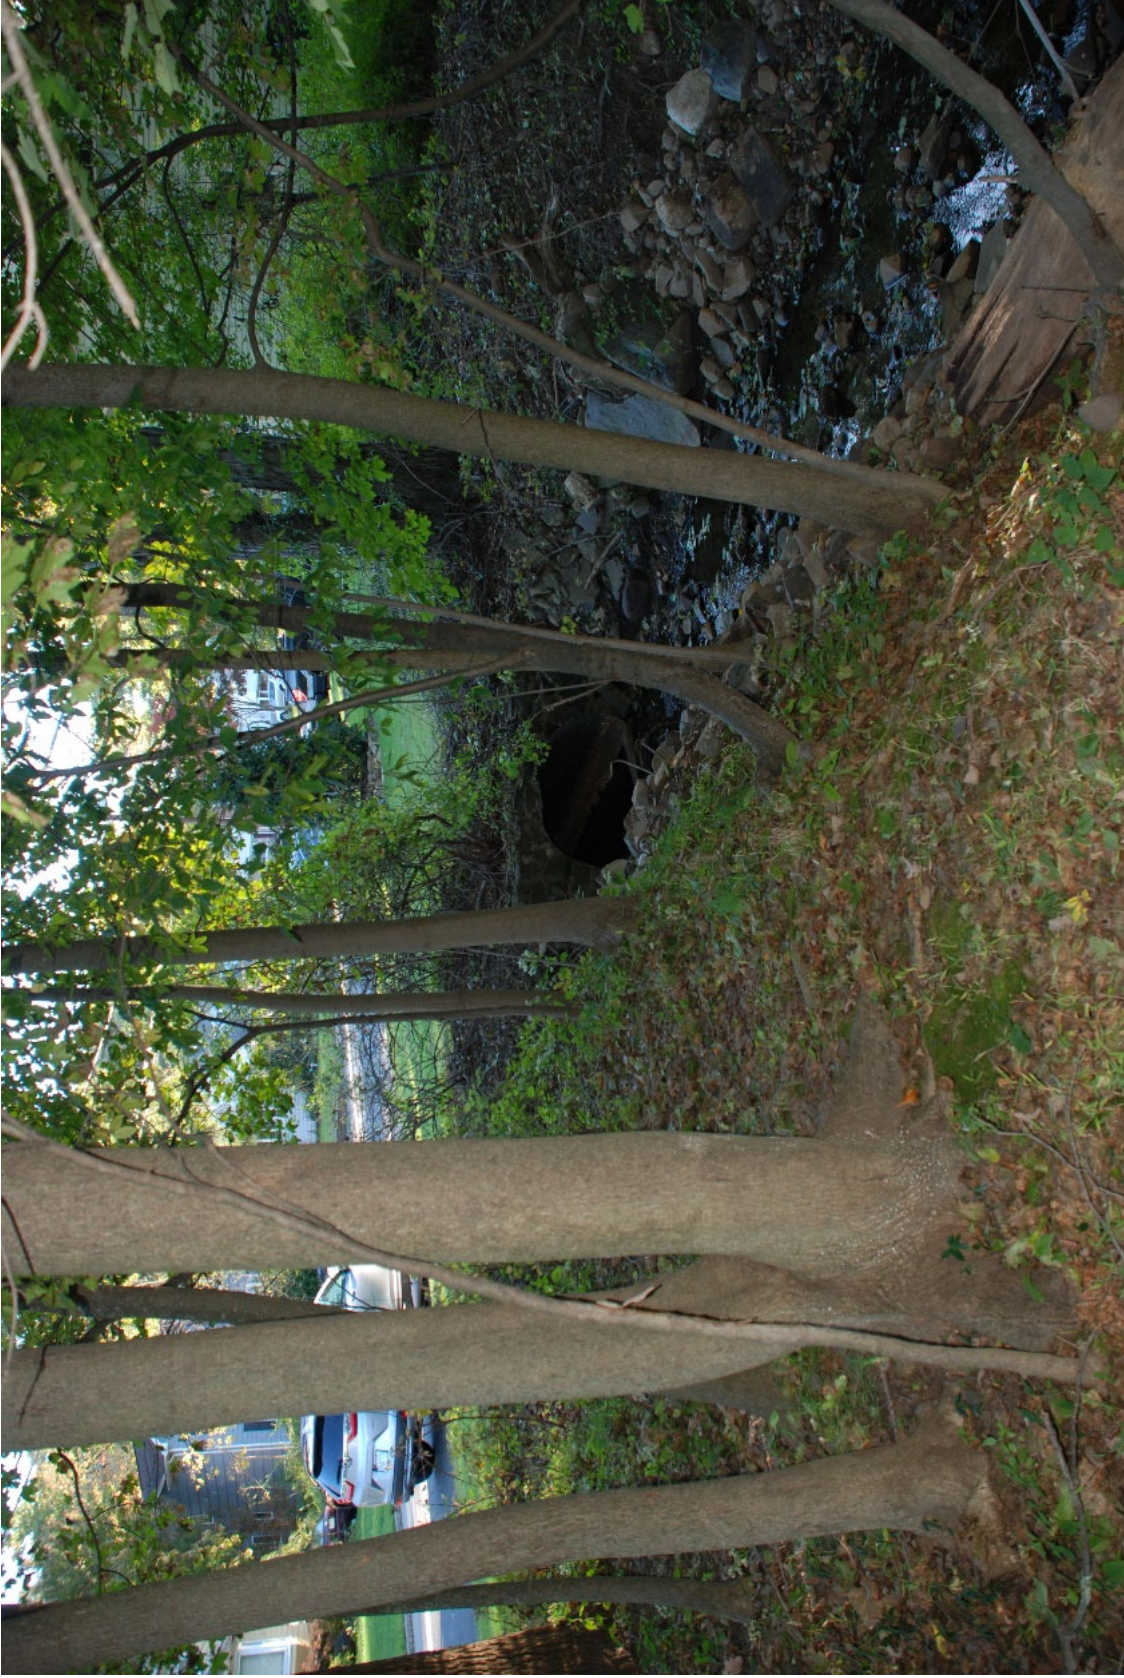
Photo 7 – View looking East at the downstream portion of the culvert that passes beneath Glenview Road. Note the material and size of the culvert changes as it passes through Glenview Road. The culvert passing under Glenview Road is comprised of two pipes in series. The first pipe is a 36" reinforced concrete pipe (RCP), followed by a 60"x41" corrugated metal elliptical pipe (CMEP).

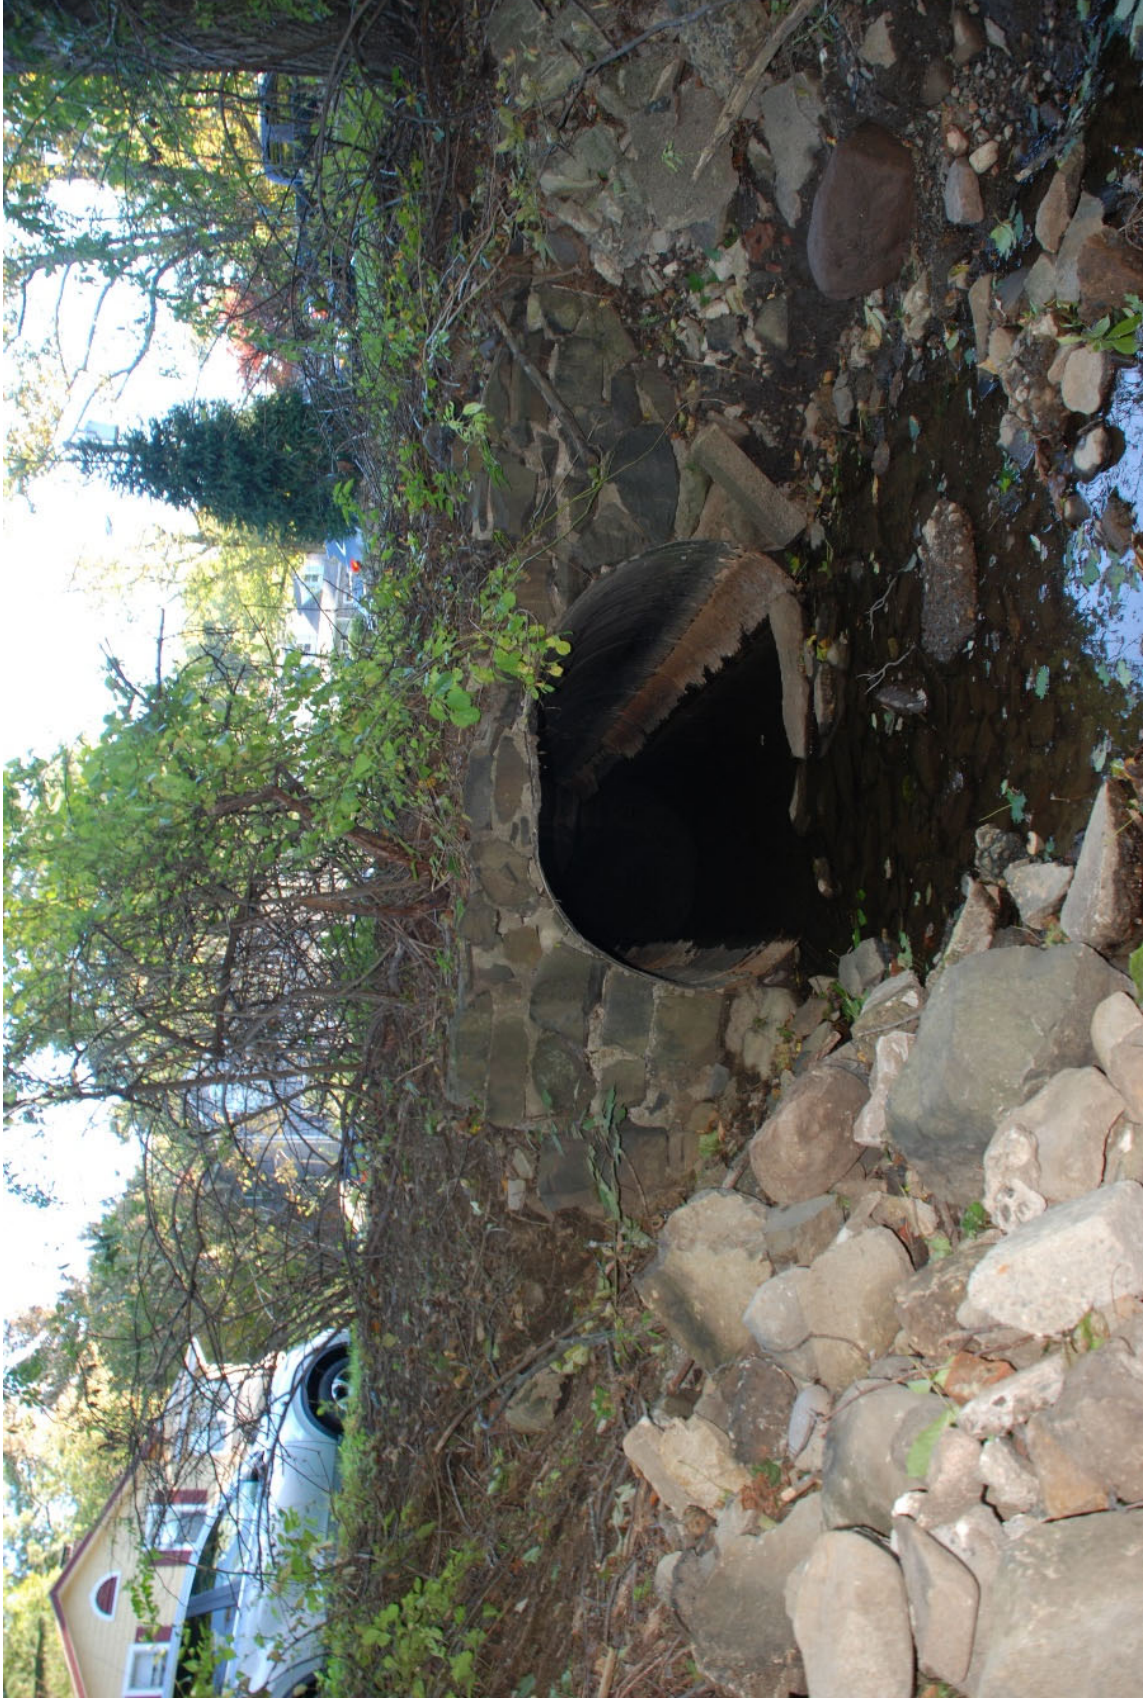
Photo 8 – View looking East showing a close-up and more detailed view of the downstream portion of the culvert.

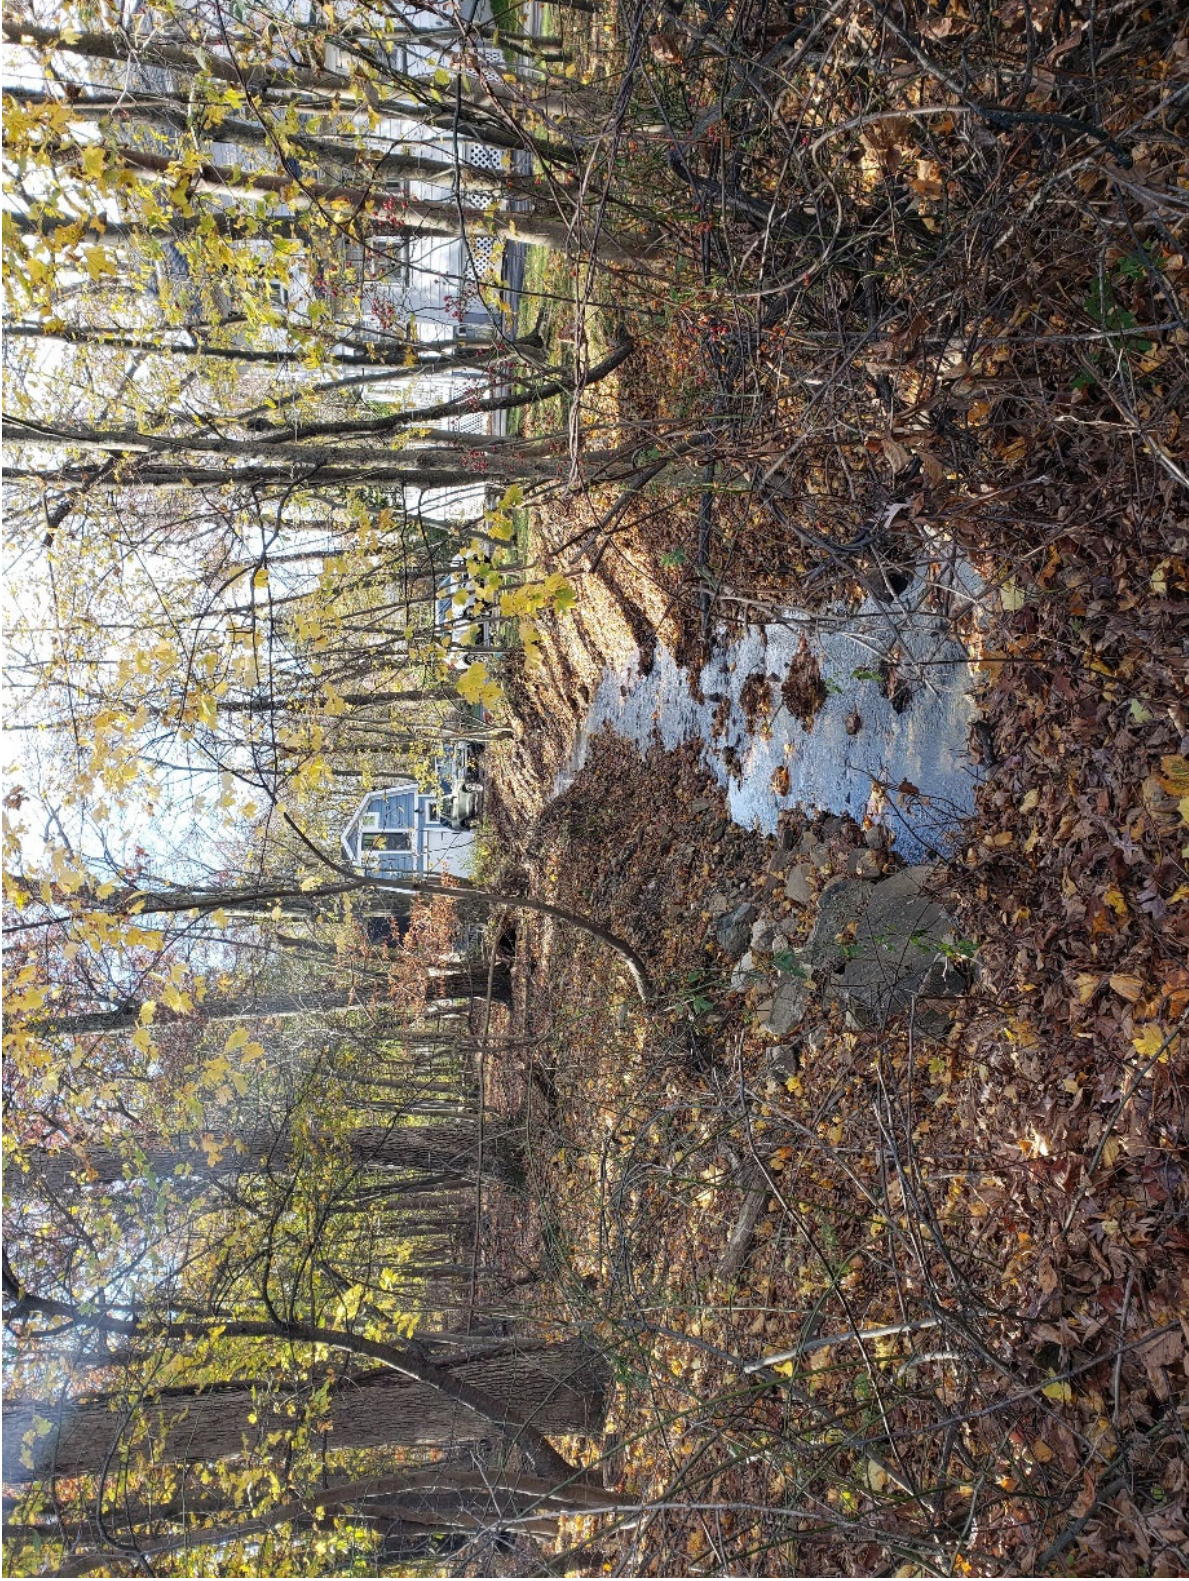
Photo 9 – View looking southwest and downstream at the Un-Coded Tributary after it has completely passed through the culvert beneath Glenview Road.

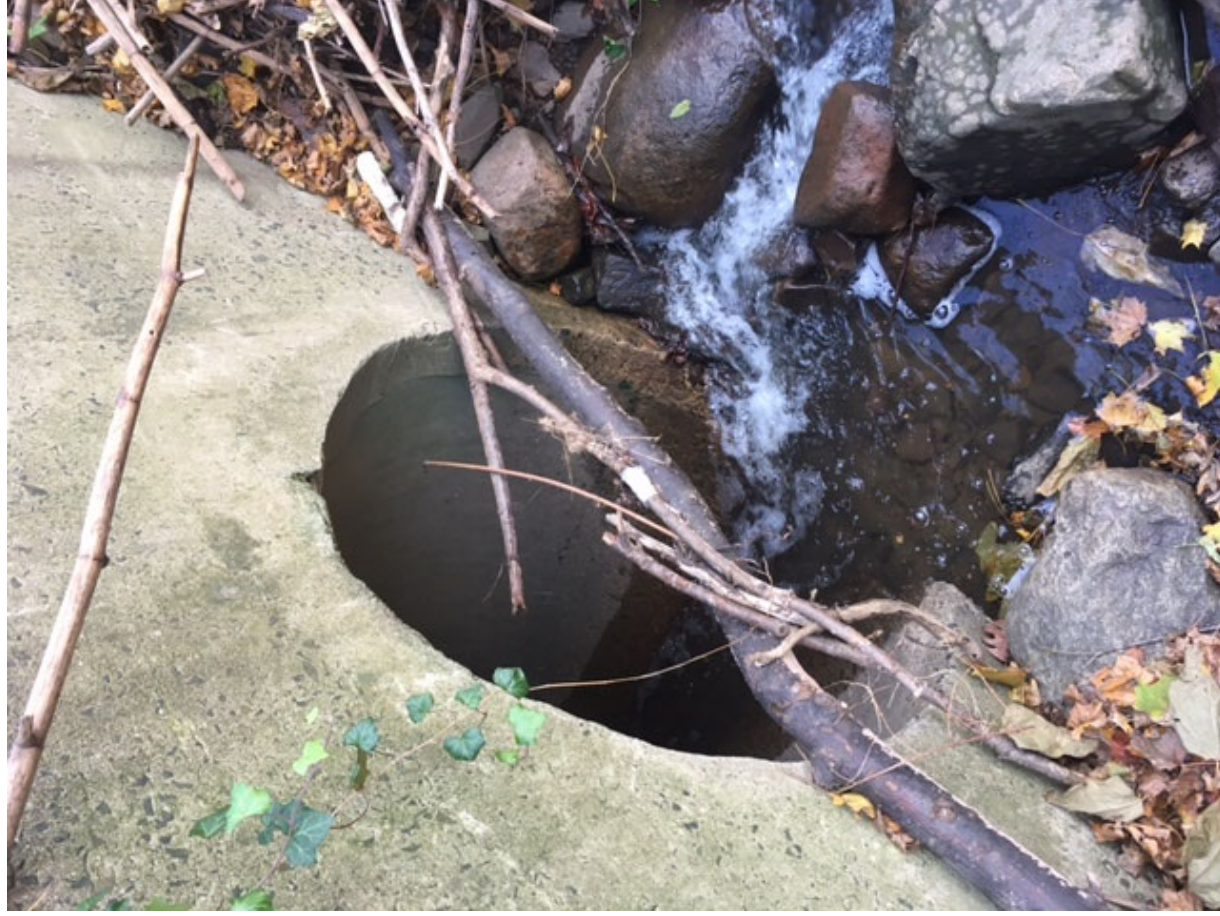
We note in our studies that the Ferndale Road Culvert, located approximately 1,300 feet downstream of the Glenview Culvert, can only convey flows from the 10-year storm. In a similar fashion, when this culvert fails, it also overtops the roadway. Any modifications to the Glenview Culvert need to be modeled to Ferndale to ensure that the changes do not exacerbate flooding at Ferndale.

Photo 10 – View looking South at the upstream portion of the culvert (before it passes beneath Ferndale Road) which is downstream of the Glenview Road culvert. The culvert is comprised of a 42" RCP pipe.
