**STUDY & RECOMMENDATIONS  
OF DRAINAGE IMPROVEMENTS TO  
THE GLENVIEW ROAD  
DRAINAGE DITCH & CULVERT**

**THE BOROUGH OF NORTH CALDWELL**

**PETRY ENGINEERING, LLC**

**JANUARY 10, 2019**

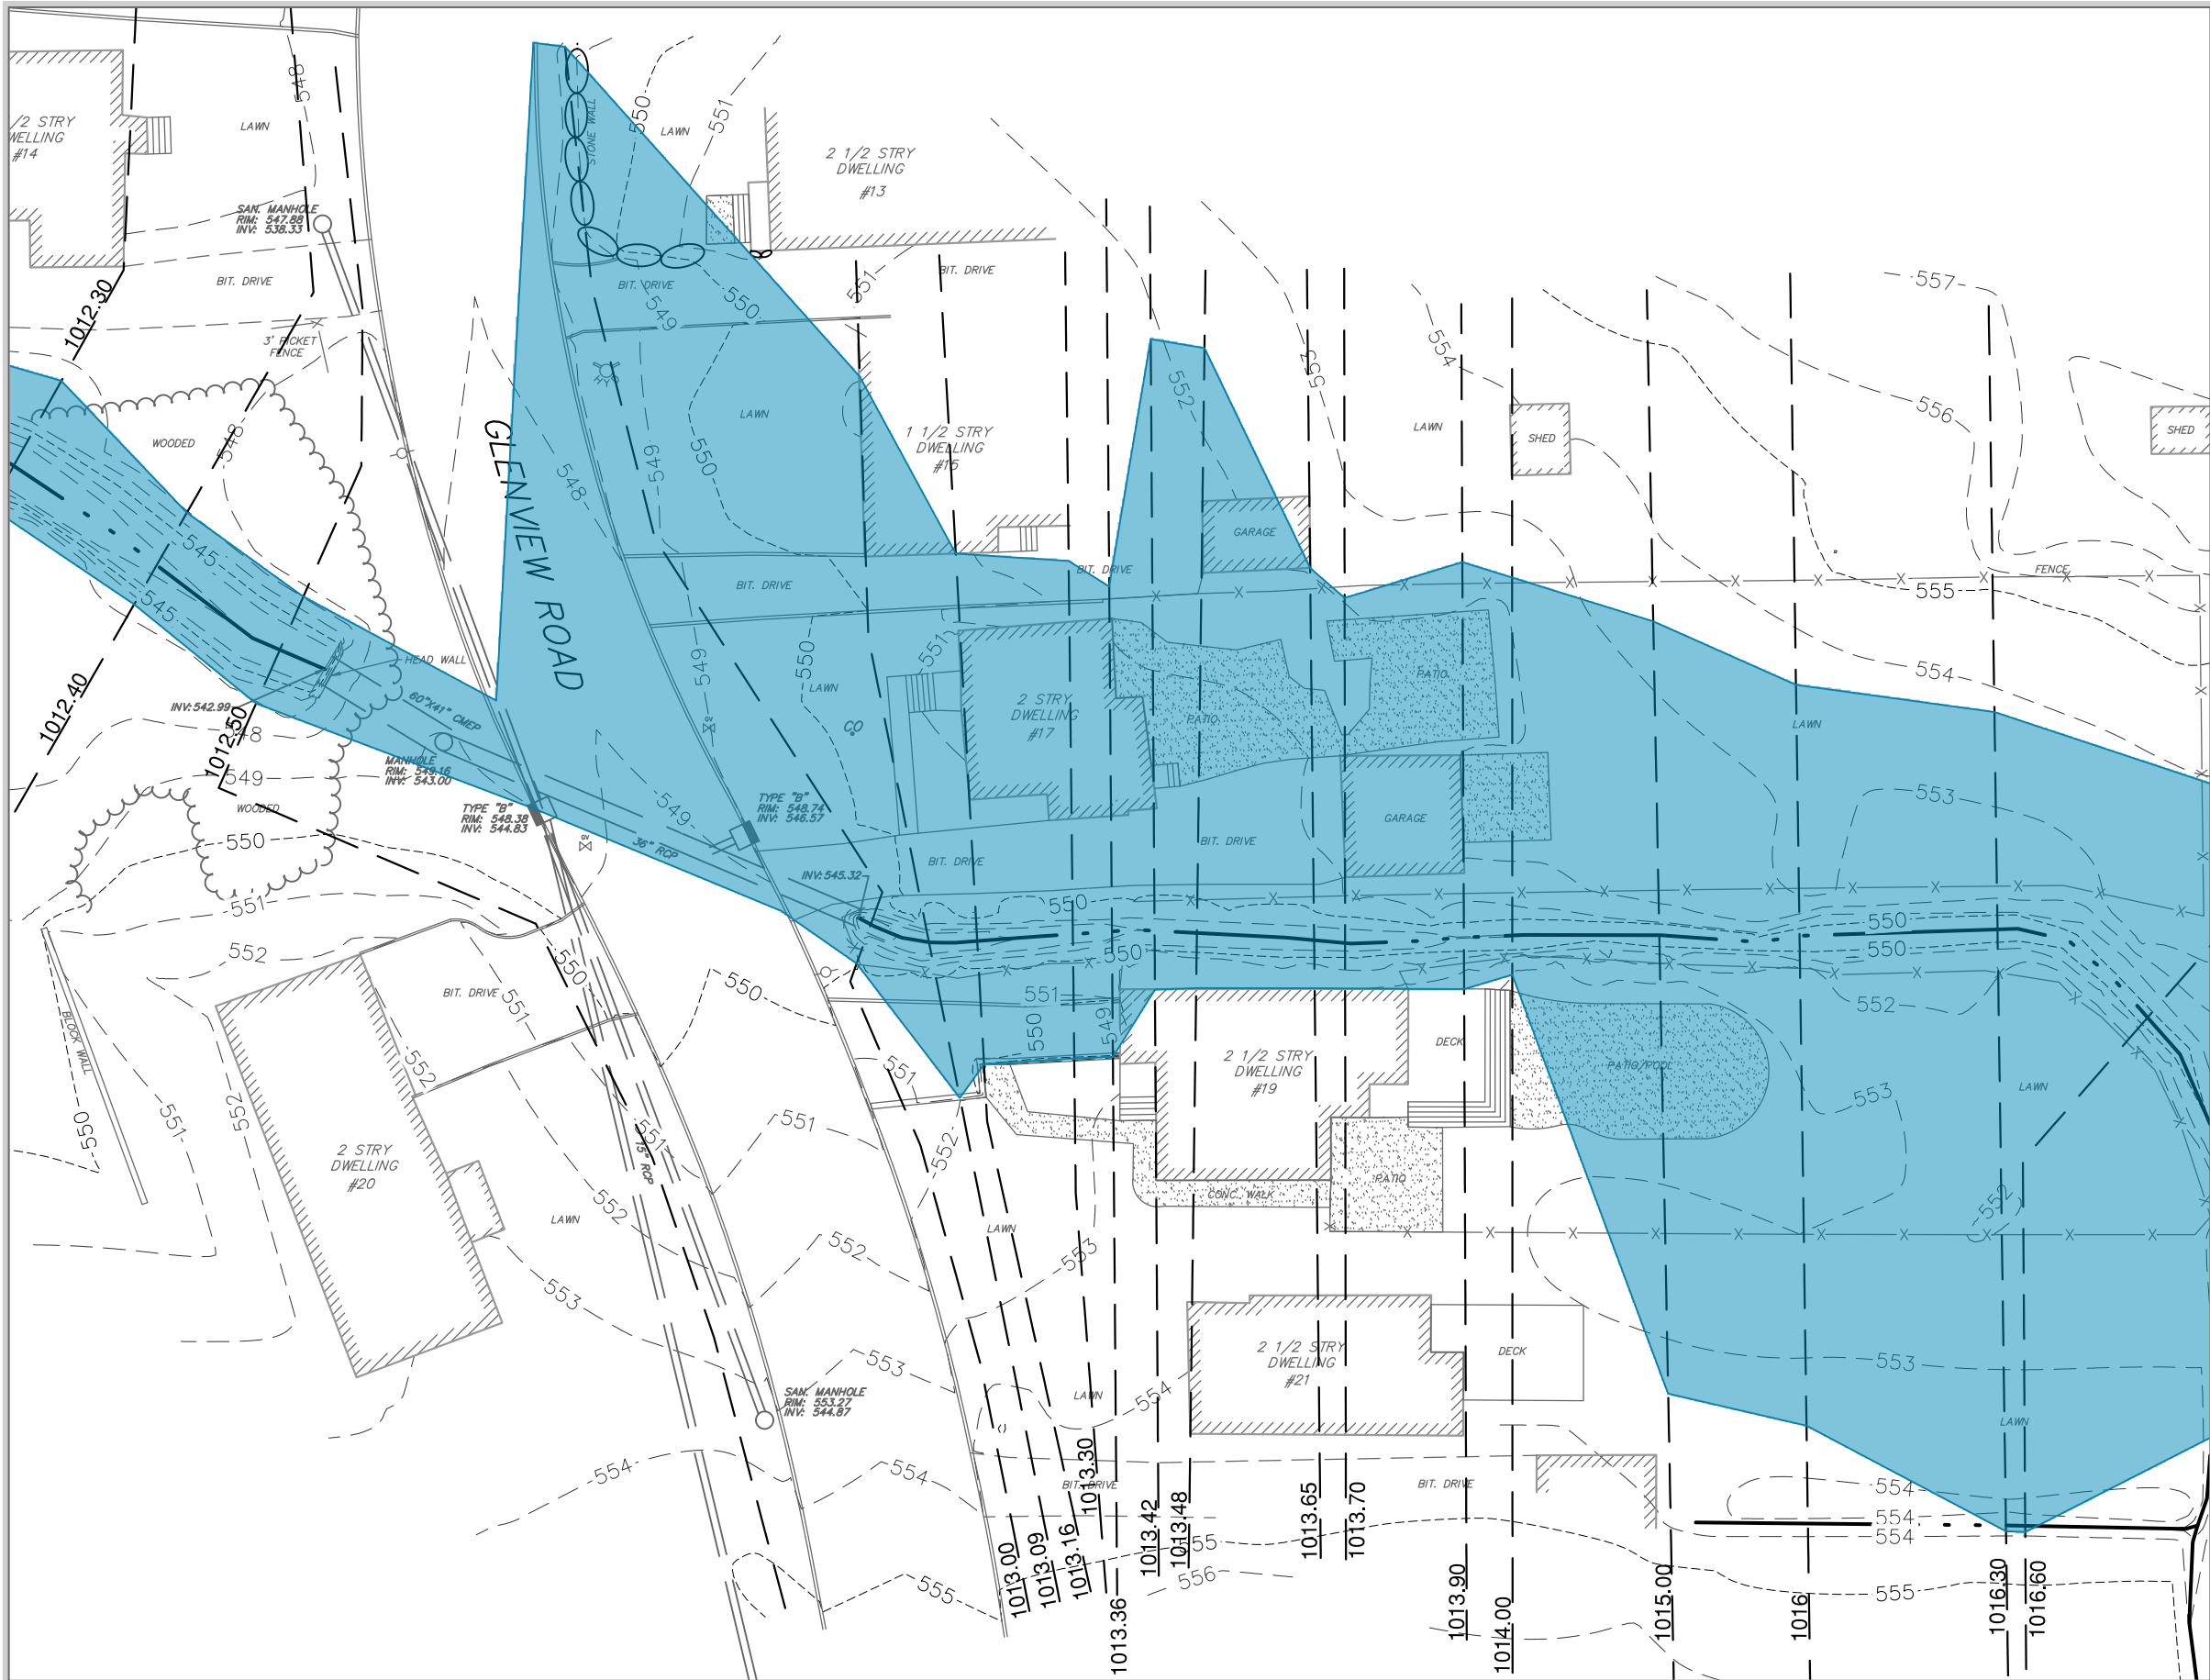
Designer: JMP  
Draftsman: CVF  
Checked By: JMP  
Project No.: 19-0216  
Scale: 1" = 30'  
Sheet:  
**FIG-4**

Our analysis shows that virtually every storm event overtops the Glenview roadway, thereby flooding the adjacent homes and the yards of several nearby homes. The following chart shows the water surface elevations associated with the various storms in the existing conditions. Please note that the curb at the roadway crossing is at elevation 549.3, so every elevation above that would overtop the roadway at the crossing location.

**EXISTING CONDITIONS  
PRE-DEVELOPMENT 100-YEAR FLOOD**

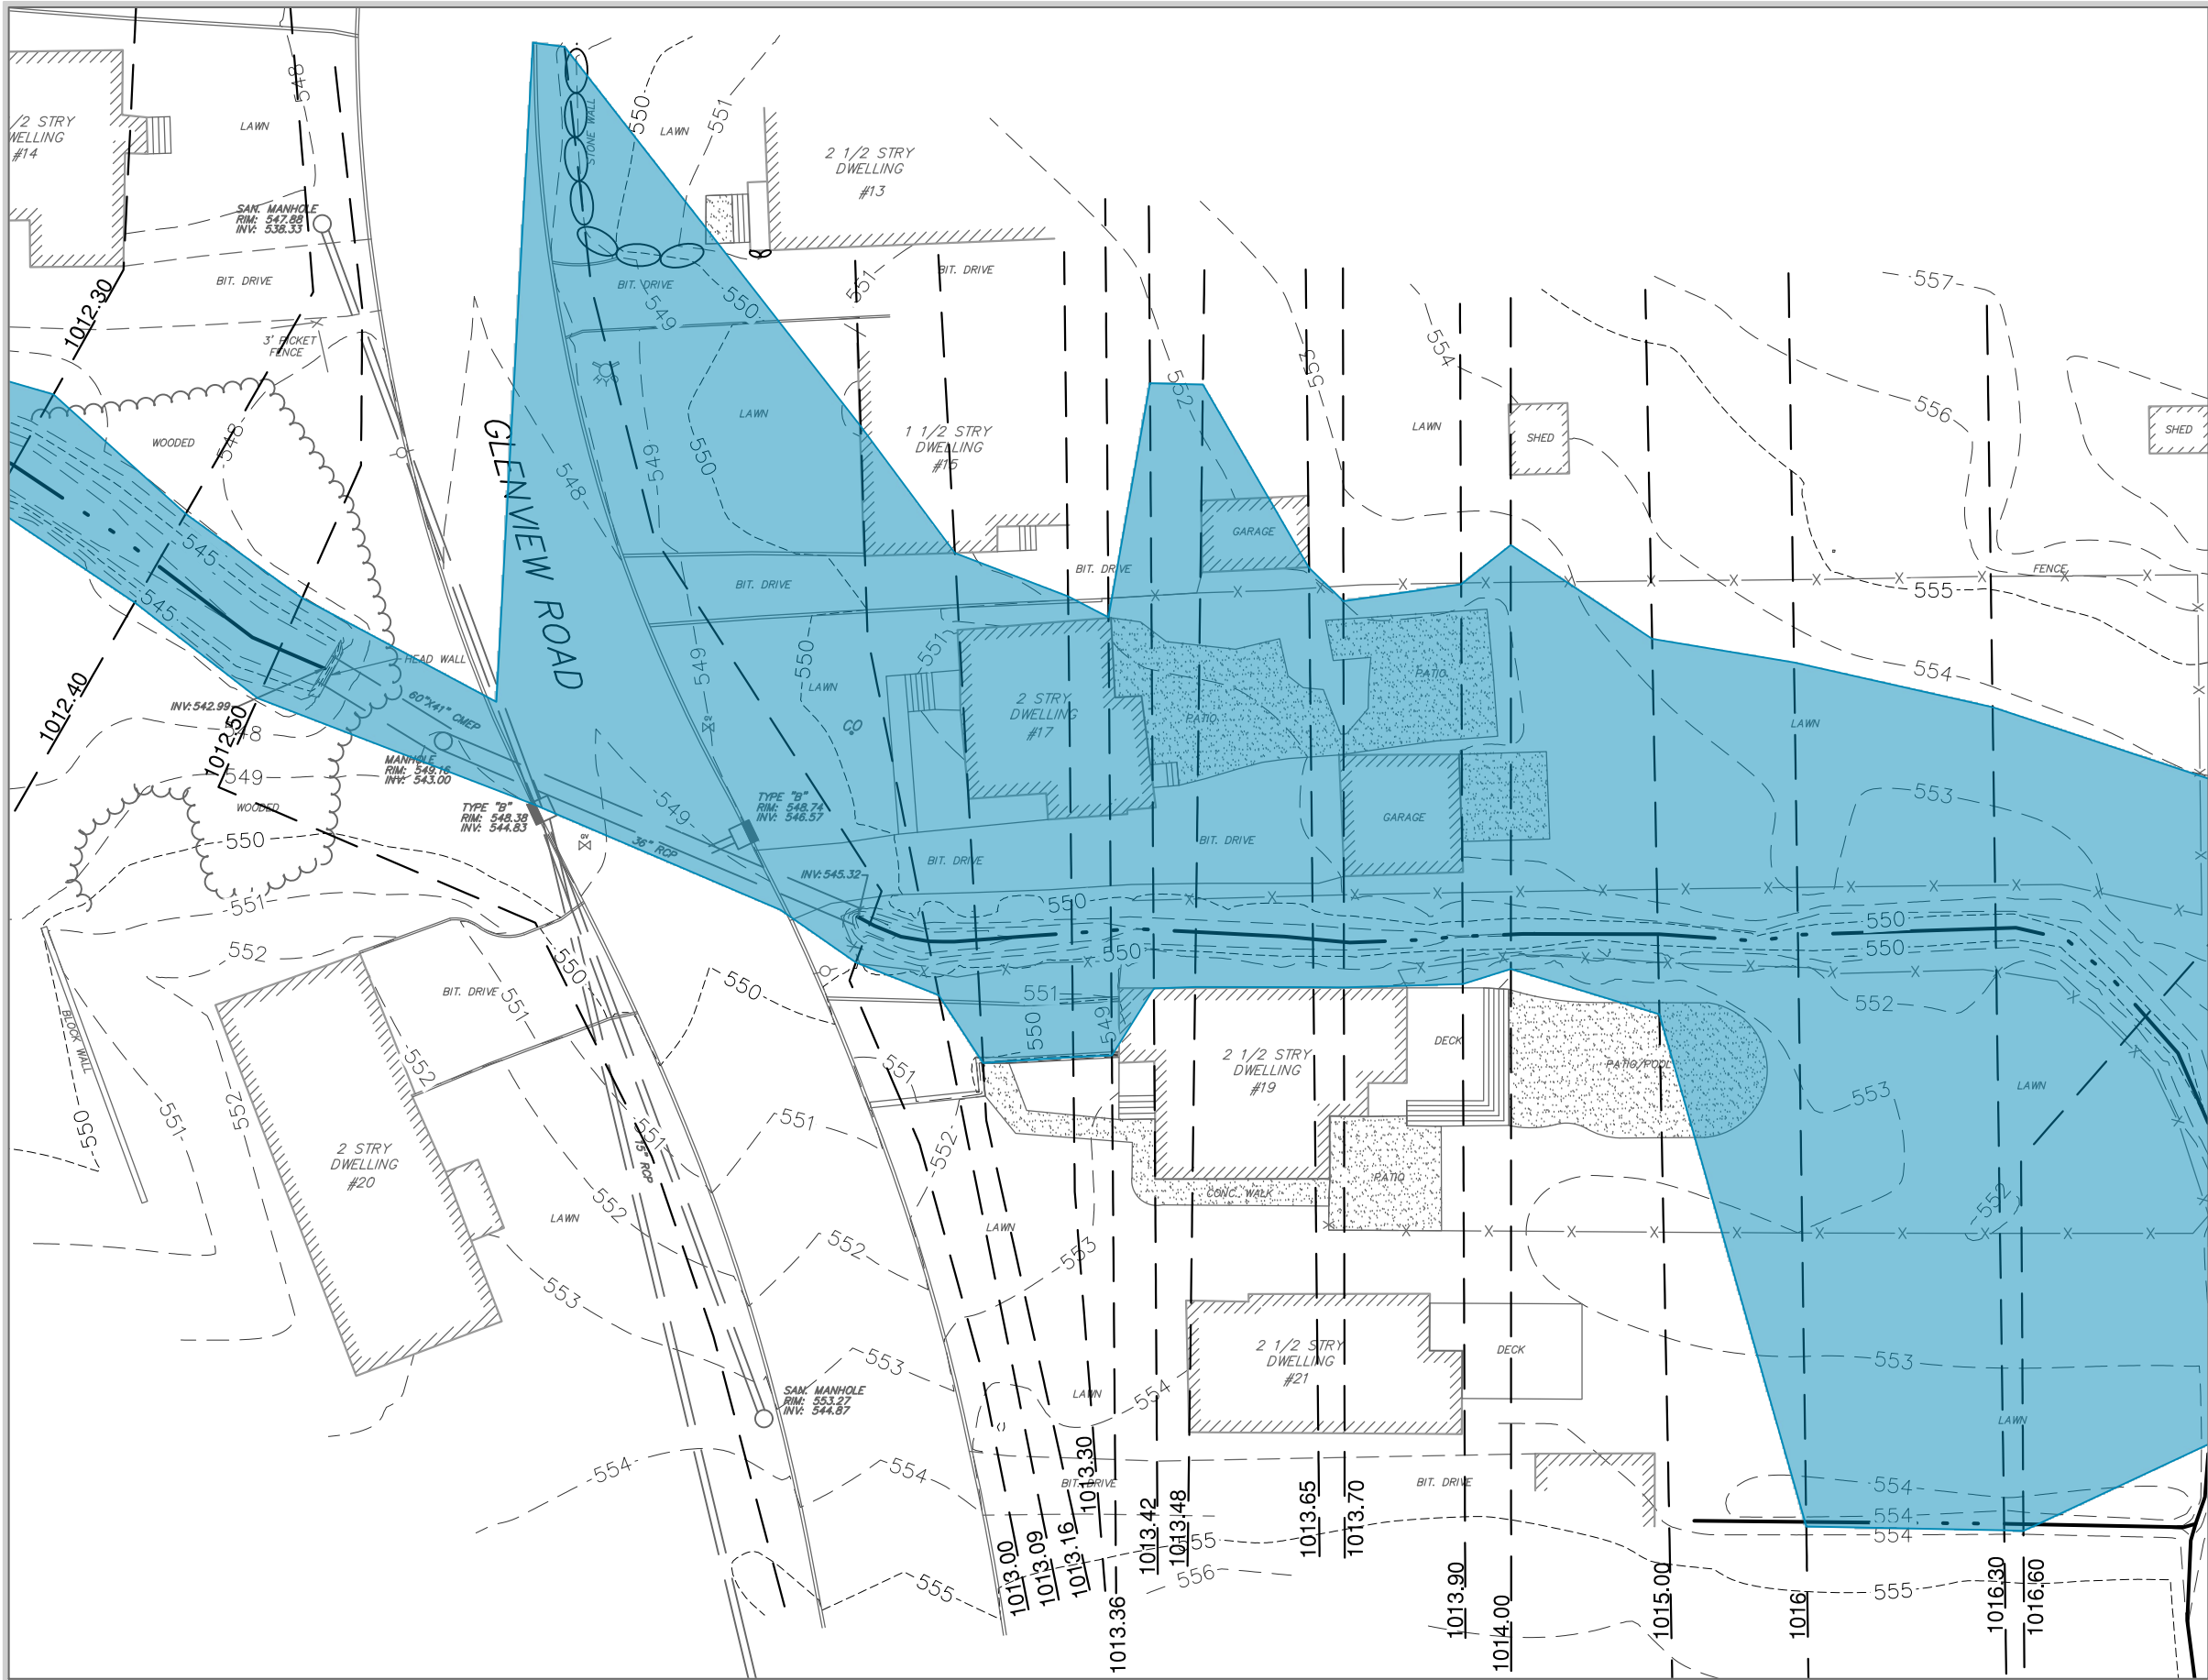
Designer: JMP  
Draftsman: CVF  
Checked By: JMP  
Project No.: 19-0216  
Scale: 1" = 30'  
Sheet:  
**FIG-5**

**EXISTING CONDITIONS  
POST-DEVELOPMENT 100-YEAR FLOOD**
